IOM TYPHOON HAIYAN (YOLANDA) RESPONSE

**DAMAGE ASSESSMENT OF DESIGNATED
EVACUATION CENTRES IN TYPHOON-AFFECTED
AREAS
EASTERN SAMAR, PHILIPPINES
*APRIL 2014***

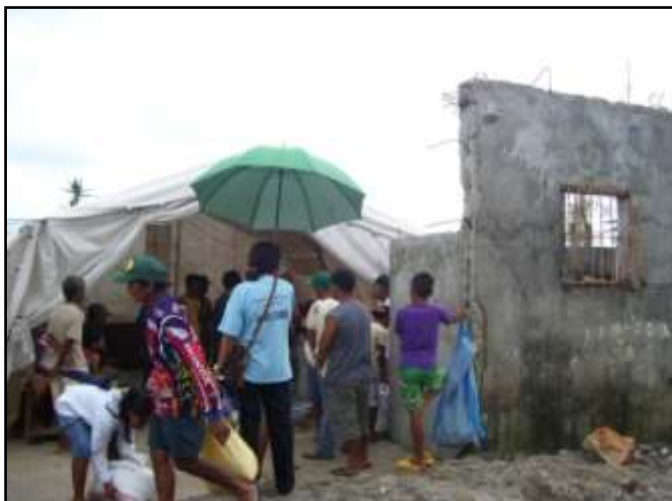
Former health centre of barangay Paya (Giporlos Municipality), a designated evacuation centre entirely damaged by Yolanda Typhoon (March 2014).

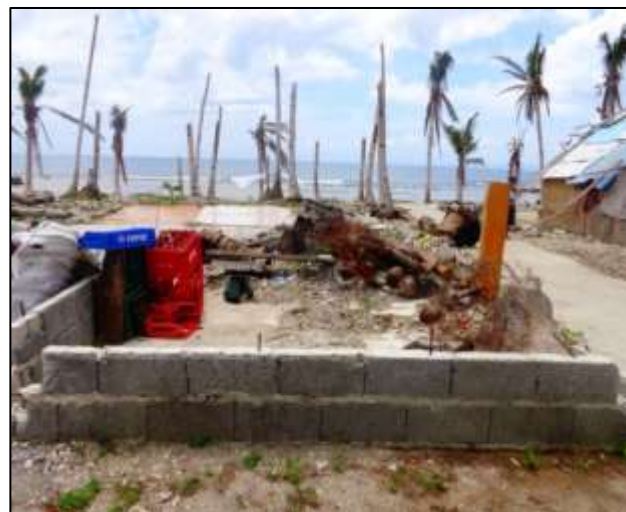
Amambucale day care centre, barangay Amambucale Marabut Municipality (March 2014)

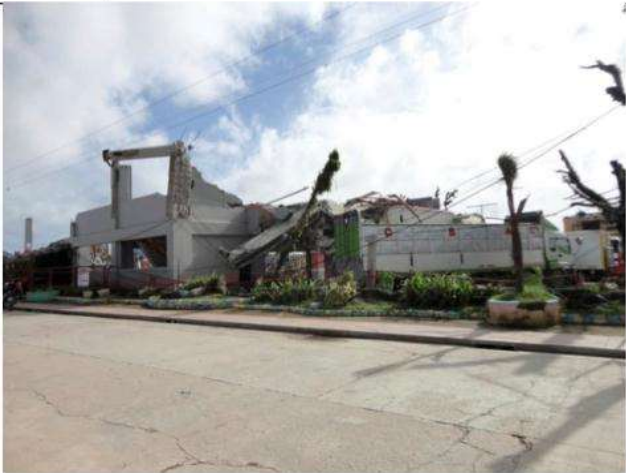
GUIUAN GYMNASIUM (GUI - 001)

| ASSESSMENT OF DESIGNATED (PRE-TYPHOON YOLANDA) EVACUATION CENTRES | | | |
|---|---|---|---|
| DAMAGE ASSESSMENT (POST-TY YOLANDA) <ul style="list-style-type: none"> • ROOF SHEETINGS\TRUSSES • BEAMS\GIRDERS • COLUMNS • WALLS • FOUNDATION • DOORS\WINDOWS | <ol style="list-style-type: none"> 1. THE WHOLE ROOF STRUCTURE IS TOTALLY DAMAGED AND THE CGI SHEETS WERE BLOWN AWAY. 2. REMAINING TRUSSES AND PURLINS ARE TWISTED AND BENT. 3. GIRDERS, BEAMS AND COLUMNS WERE DAMAGED AND SOME HAVE FALLEN OR ABOUT TO. 4. THOUGH THE WALLS, IN GENERAL ARE STILL INTACT, SOME PARTS HAVE CRACKS OR HAVE FALLEN. 5. DOORS AND WINDOWS ARE DAMAGED. | | |

| ASSESSMENT OF DESIGNATED (PRE-TYPHOON YOLANDA) EVACUATION CENTRES | | | |
|---|---|---|---|
| NECESSARY REPAIR\REMEDIAL WORKS | <ol style="list-style-type: none"> 1. DEMOLISH THE DAMAGED STRUCTURAL MEMBERS AND REMOVE\DISPOSE THE DEBRIS. 2. CONSTRUCT A NEW STORM-RESILIENT BUILDING RATHER THAN REPAIRING THE REMAINING STRUCTURE. | | |
