IOM TYPHOON HAIYAN (YOLANDA) RESPONSE

**DAMAGE ASSESSMENT OF DESIGNATED
EVACUATION CENTRES IN TYPHOON-AFFECTED
AREAS
EASTERN SAMAR, PHILIPPINES
*APRIL 2014***

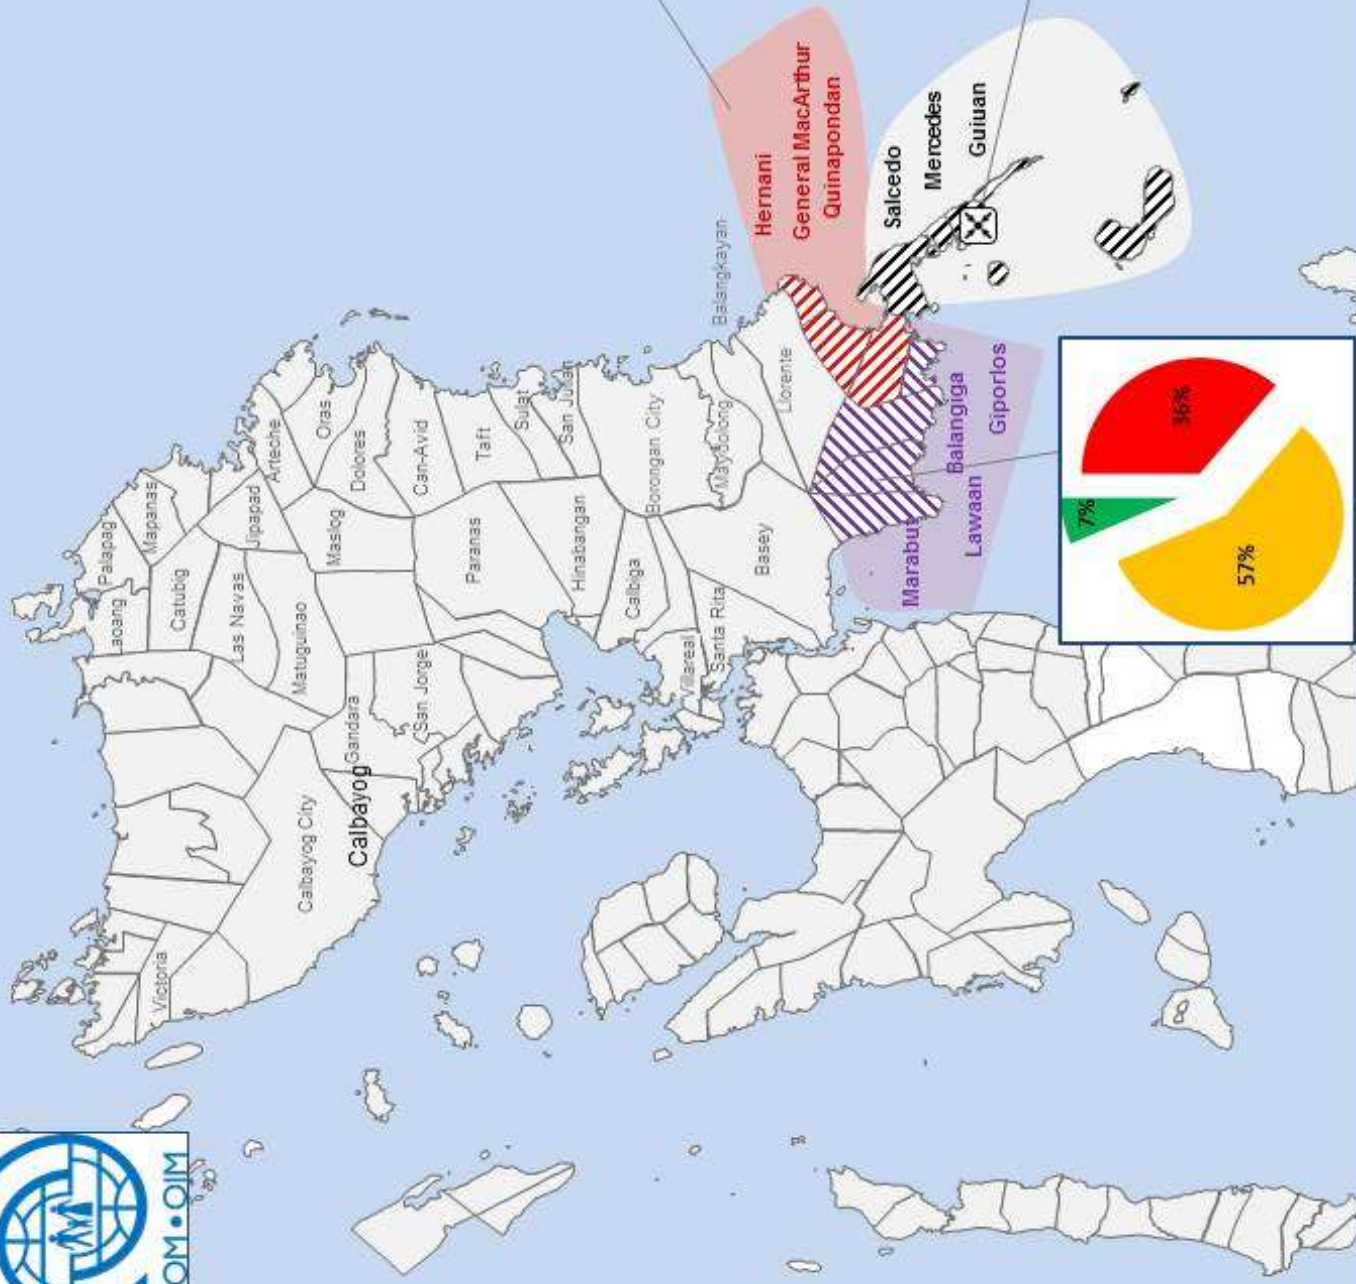
Current status of designated evacuation centres per coast line (April 2014)

■ Evacuation centres **completely destroyed, and currently not usable.**
■ Evacuation centre **completely damaged and currently not usable.**
■ Evacuation centres with **minor damages (or no damages) and currently usable.**
✕ Shelter Coordination Cluster (GUIUAN Hub)

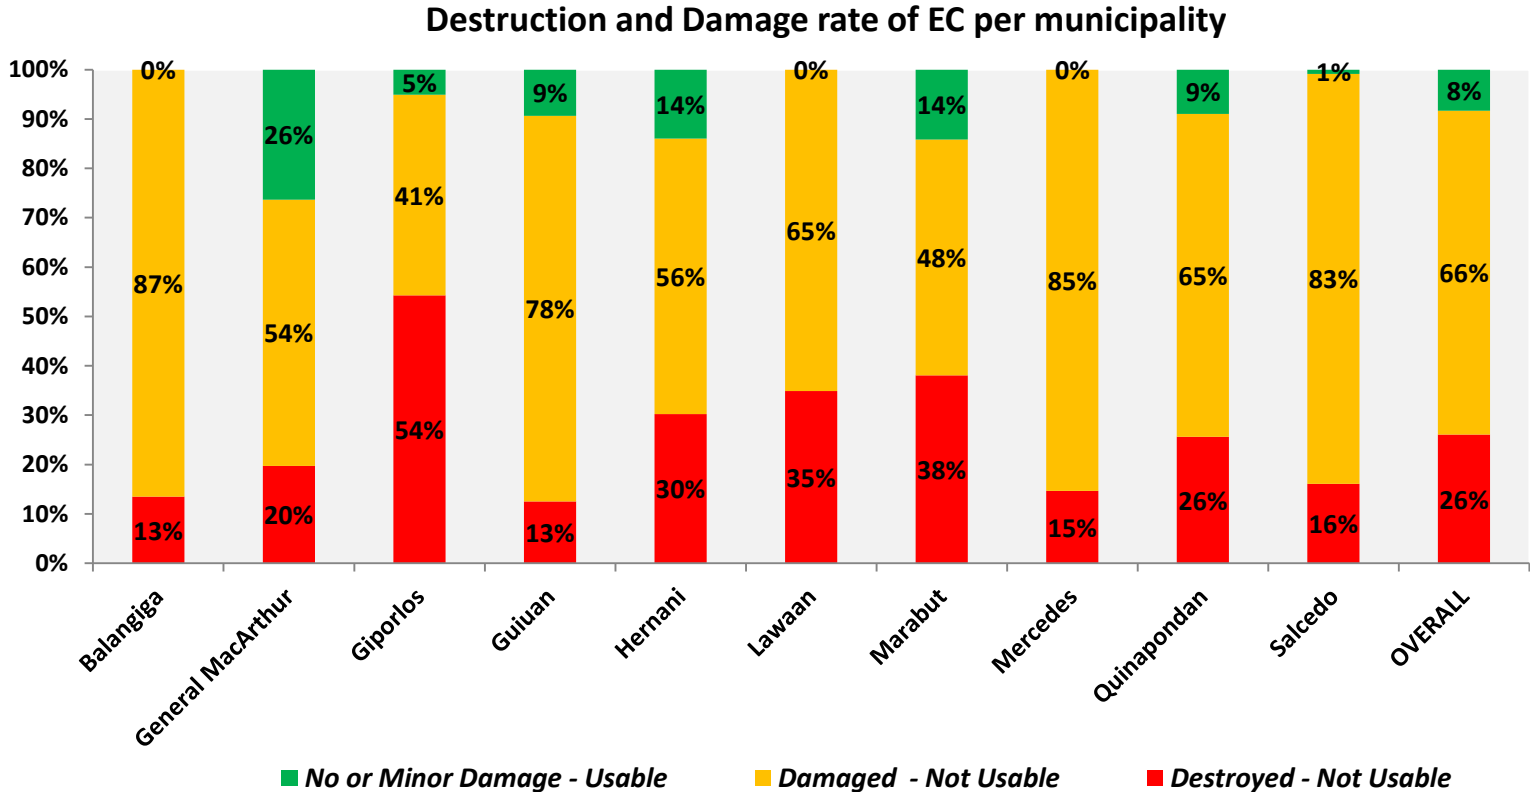
A closer look at disaggregated data suggests that municipalities with settlements concentrated on the coastline and where storm surge was significant, experienced the highest level of destruction. **The Municipalities of Giporlos (54%), Marabut (38%), Lawaan and Hernani (30%) have a destruction rate for their evacuation centres superior to 30% (higher than the overall average).**

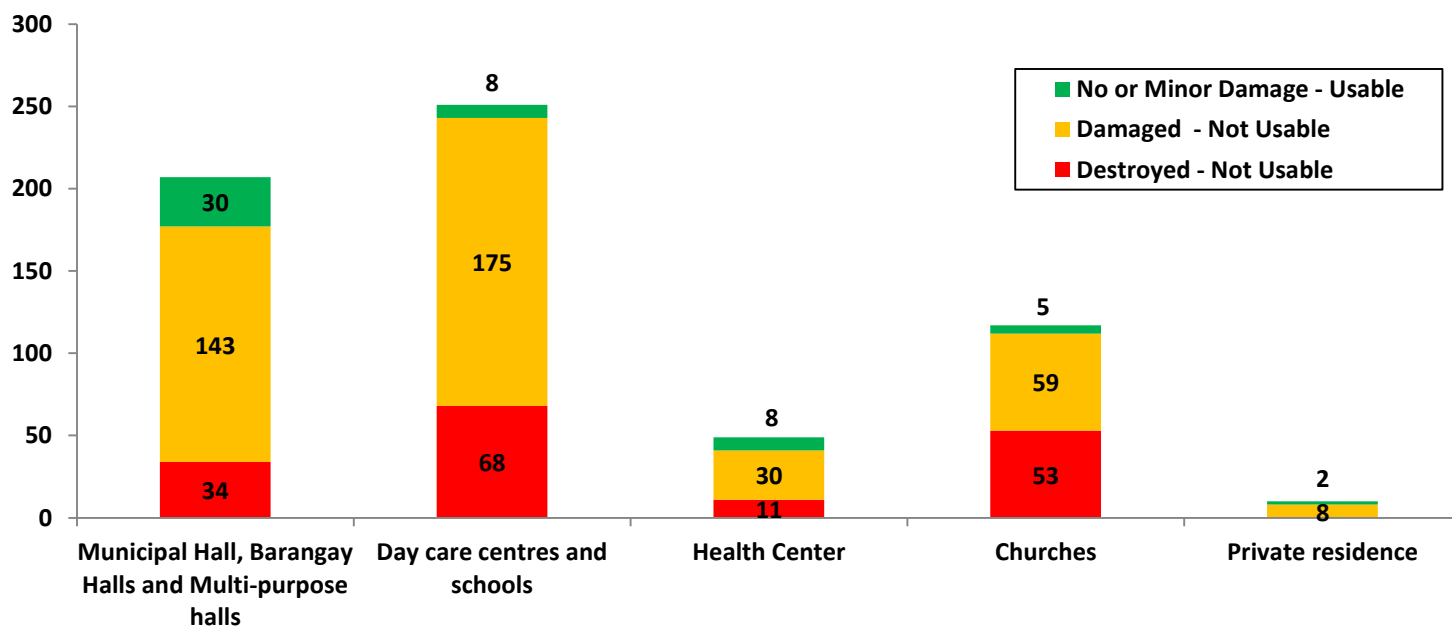
Types of evacuation centre buildings (post-Yolanda situation)

In terms of short to immediate reconstruction needs, the results highlight the fact that 66% of all evacuation centres are damaged or destroyed and thus unusable in case of typhoon. The majority of buildings that fall in this category are schools or day care centres (175 sites) and governmental infrastructure such as Municipal Halls or Barangay Halls (143 sites). **Rehabilitating, repairing or reinforcing social infrastructure that was heavily damaged needs to be prioritised as part of a wider disaster preparedness strategy in Eastern Samar.**

In terms of longer term reconstruction needs, survey results indicate that 26% of all evacuation centres were completely destroyed and will require much more time and resources to rebuild. Most of the buildings that have been assessed as 'destroyed' are either day care centres or schools (68 sites), and to a lesser extent, churches (53 sites).

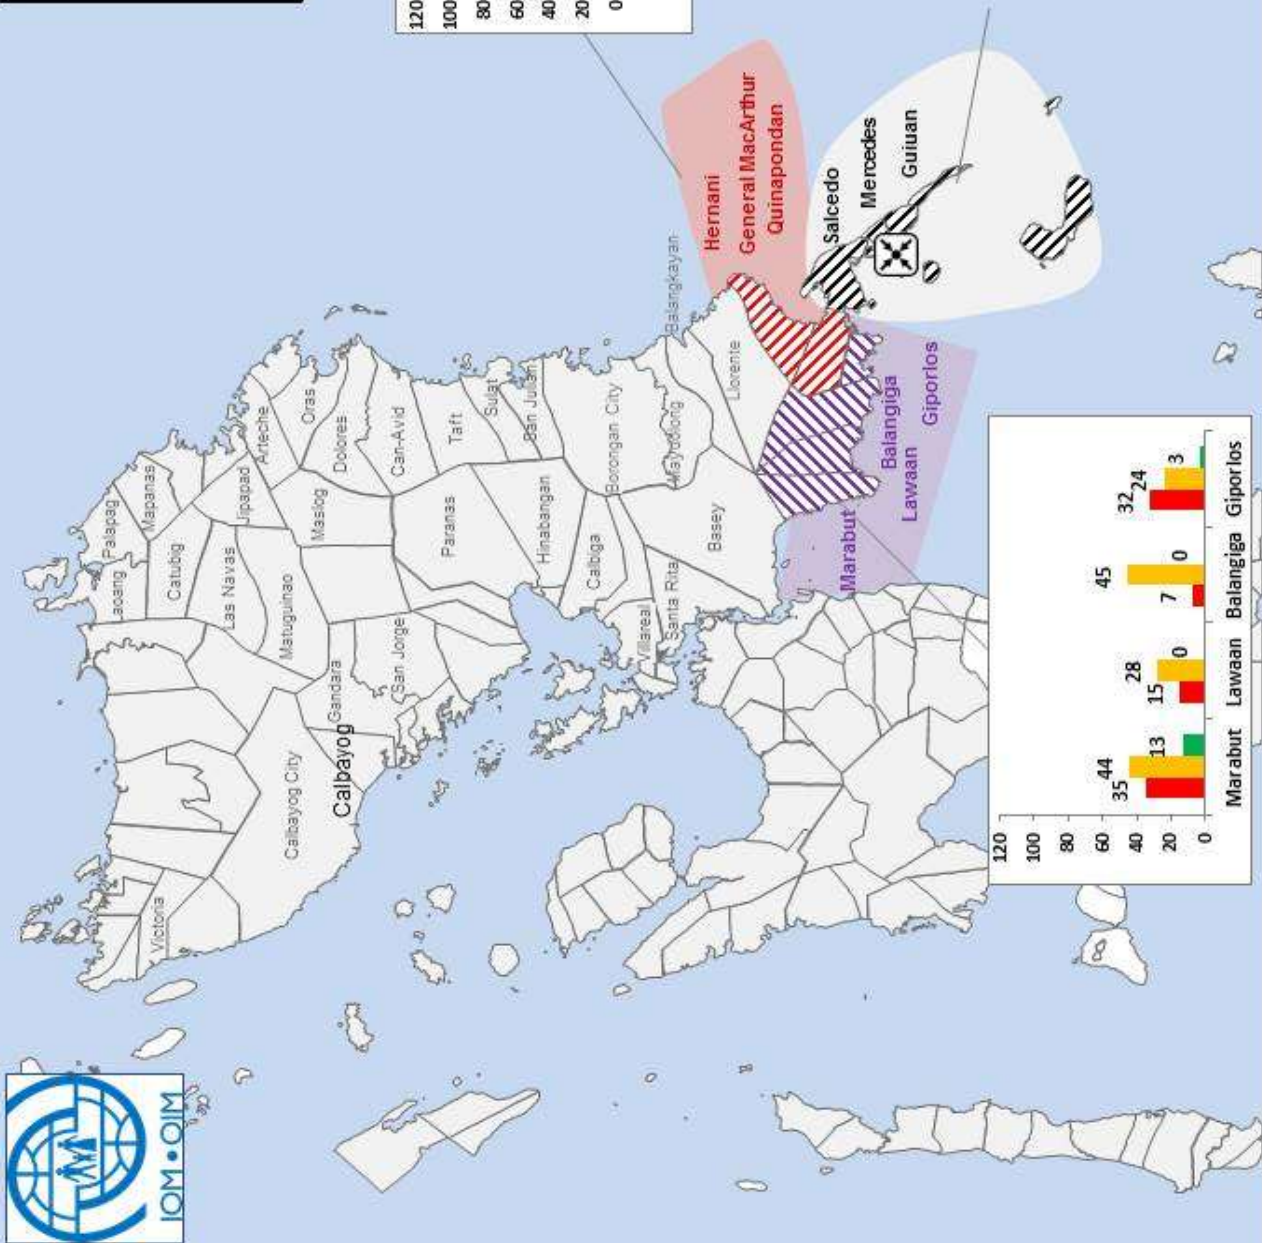
Current status of designated evacuation centres per municipality (April 2014)

■ Evacuation centres **completely destroyed, and currently not usable.**
■ Evacuation centres **completely damaged and currently not usable.**
■ Evacuation centres with **minor damages (or no damages) and currently usable.**
✕ Shelter Coordination Cluster (GUIUAN Hub)

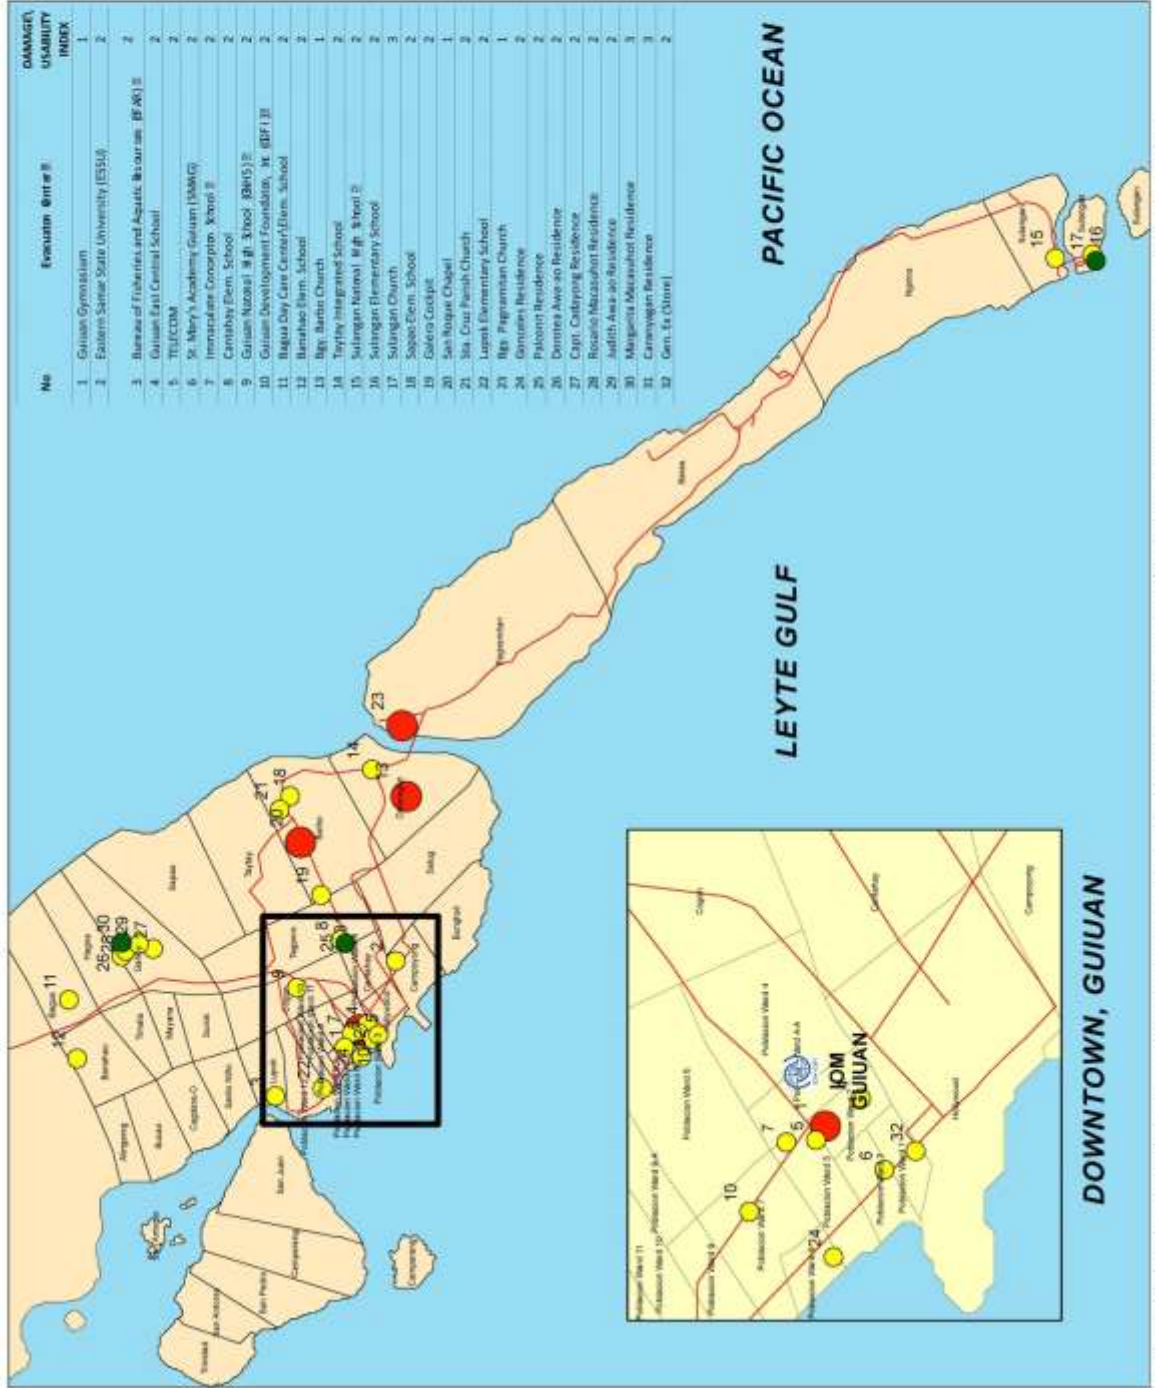
DESIGNATED EVACUATION CENTERS IN GUIJUAN (Pre - Typhoon Yolanda)

| No | Description | No. of buildings |
|---|---|---|
| 2 | Damaged - Not Usable | 15 |
| 3 | No/Minor damage - Usable | 1 |

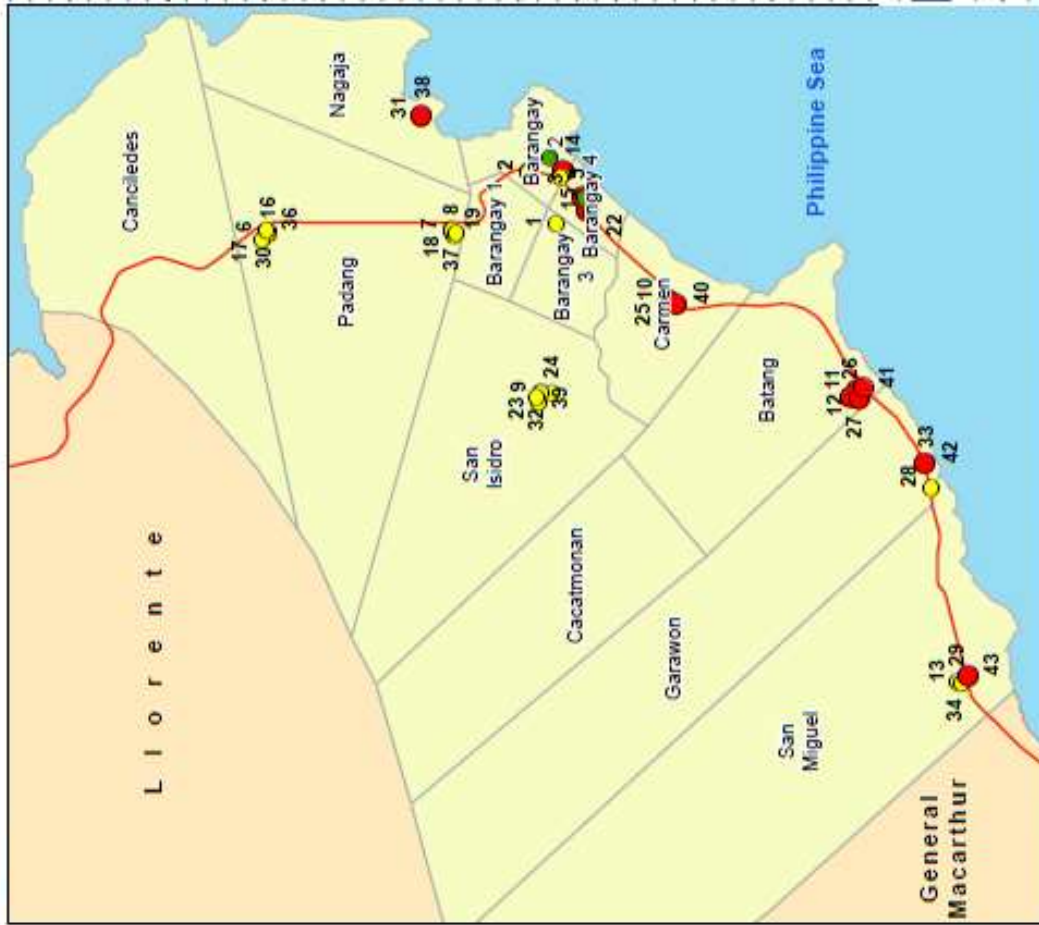
DESIGNATED EVACUATION CENTERS IN HERNANI
(Pre-Typhoon Haiyan\Yolanda)

| No. | Barangay | Evacuation Center | Usability |
|---|---|---|---|
| 1 | Hernani | HERNANI MUNICIPAL HALL | 2 |

| No. | Description | No. Of Buildings | Percentage (%) |
|---|---|---|---|
| 2 | Damaged - Not Usable | 24 | 55% |
| 3 | No/Minor Damage - Usable | 6 | 14% |
